Inspection Report

Mine Name: Golden/Lucky Chantz

Permit number: S0370064

Inspection Date: May 31, 2007

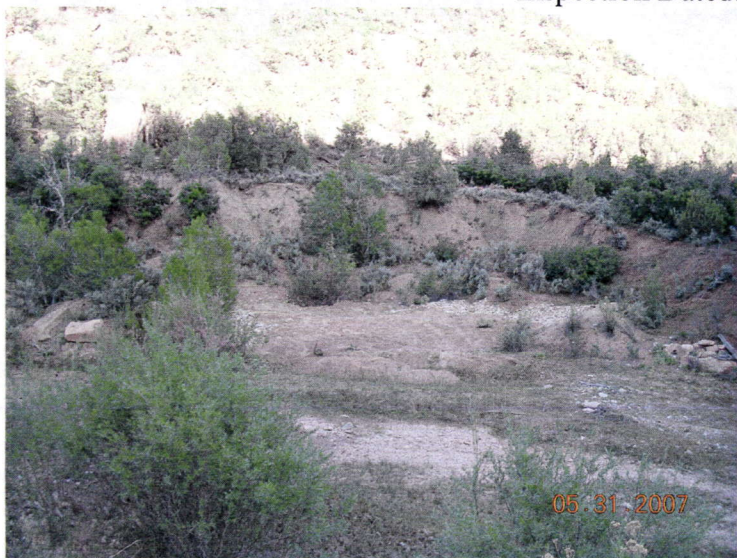
Photo 1. This is part of the upper disturbed area.

Because the operator has not completed reclamation, the Division needs to require a surety. It will be primarily for removing the equipment, but there is a small amount of grading work that will be needed. I anticipate revegetation of the area will be easy since rabbitbrush comes in very readily.

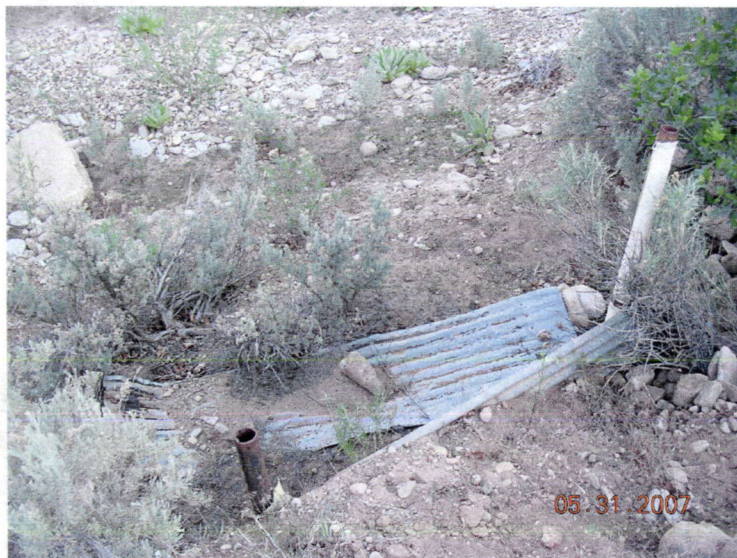
Photo 2. This appears to be a loading or unloading facility in the upper disturbed area.

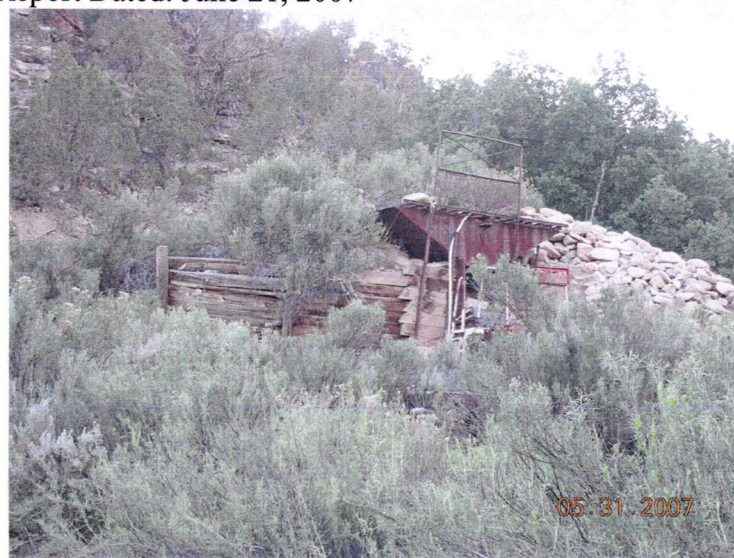
The disturbed area is in the bottom of a canyon with a lot of rabbitbrush, sagebrush, and other vegetation. Some of the disturbed areas are very overgrown with rabbitbrush.

Photo 3. Some of the processing equipment in the lower disturbed area. Note the amount of rabbitbrush.

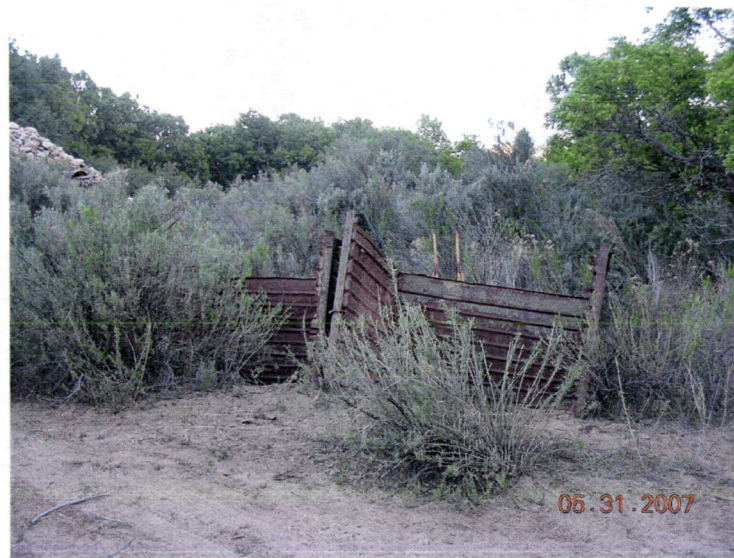
Photo 4. These bins are in the lower disturbed area.

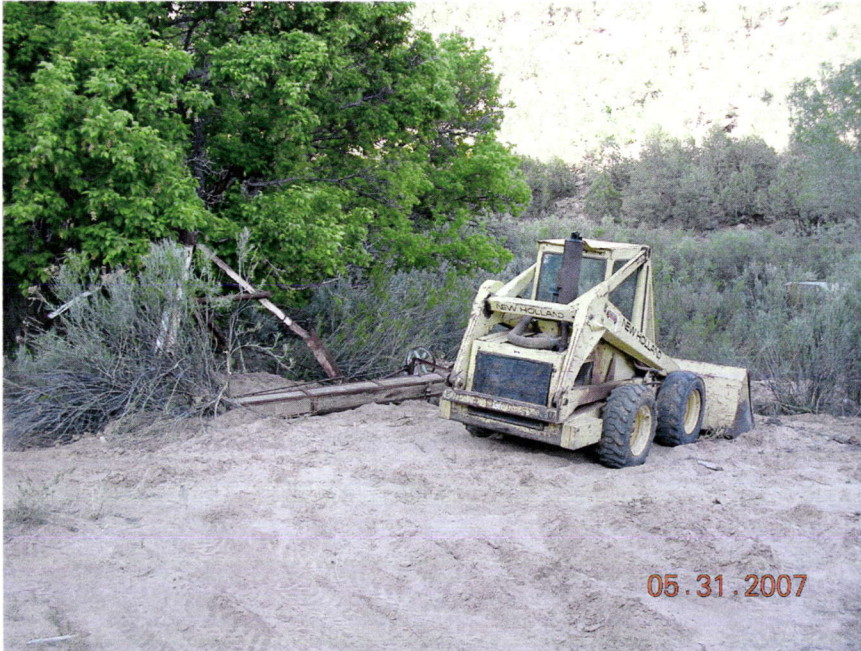
Photo 5. This loader was not present during my last inspection in October 2004. I assume the operator has been using it for some grading work.

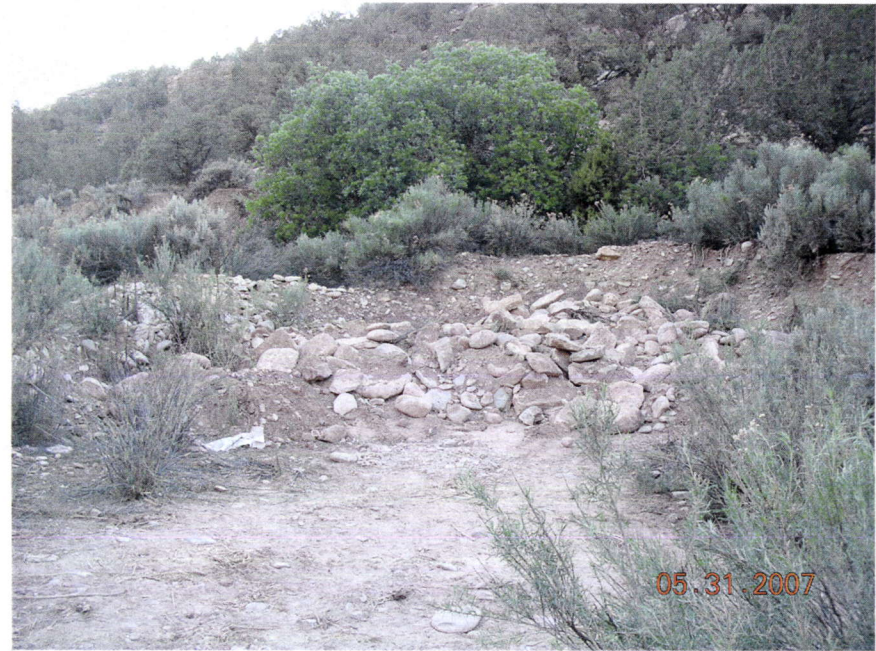
Photo 6. The operator has done limited regrading.
